AN OFFPRINT FROM
DUMBARTON OAKS PAPERS
Number 21

WORK AT KALENDERHANE CAMII IN ISTANBUL:
FIRST PRELIMINARY REPORT

CECIL L. STRIKER and Y. DOĞAN KUBAN

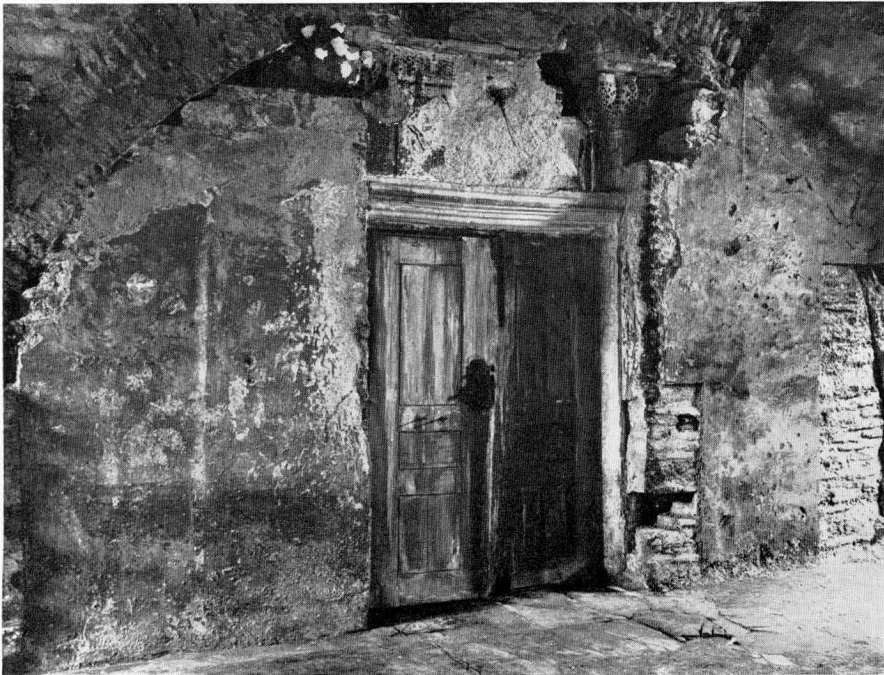
2. West Wall of Esonarthex

The most significant finds were brought to light to the south of this structure imbedded in the wall separating the two narthexes. Soundings in this wall revealed substantial remains of a tribelon system (Phase II), complete with its columns, capitals, and lintel (figs. A, B, and 2). The system is flanked by two massive stone piers to the north and south, each pier measuring one meter in breadth, and rising one meter above the present floor level of the esonarthex, at which point it is cut. Between the piers are two marble columns, placed so as to divide the seven-meter space into three passages of equal width. A heavy molded lintel spans the two meters between the columns, and the door thus formed serves as the present entrance to the esonarthex. Surmounting each of the columns are well-preserved melon capitals in *à jour* technique, in turn bearing impost blocks (fig. 3). The very close similarity of the capitals to those in the north

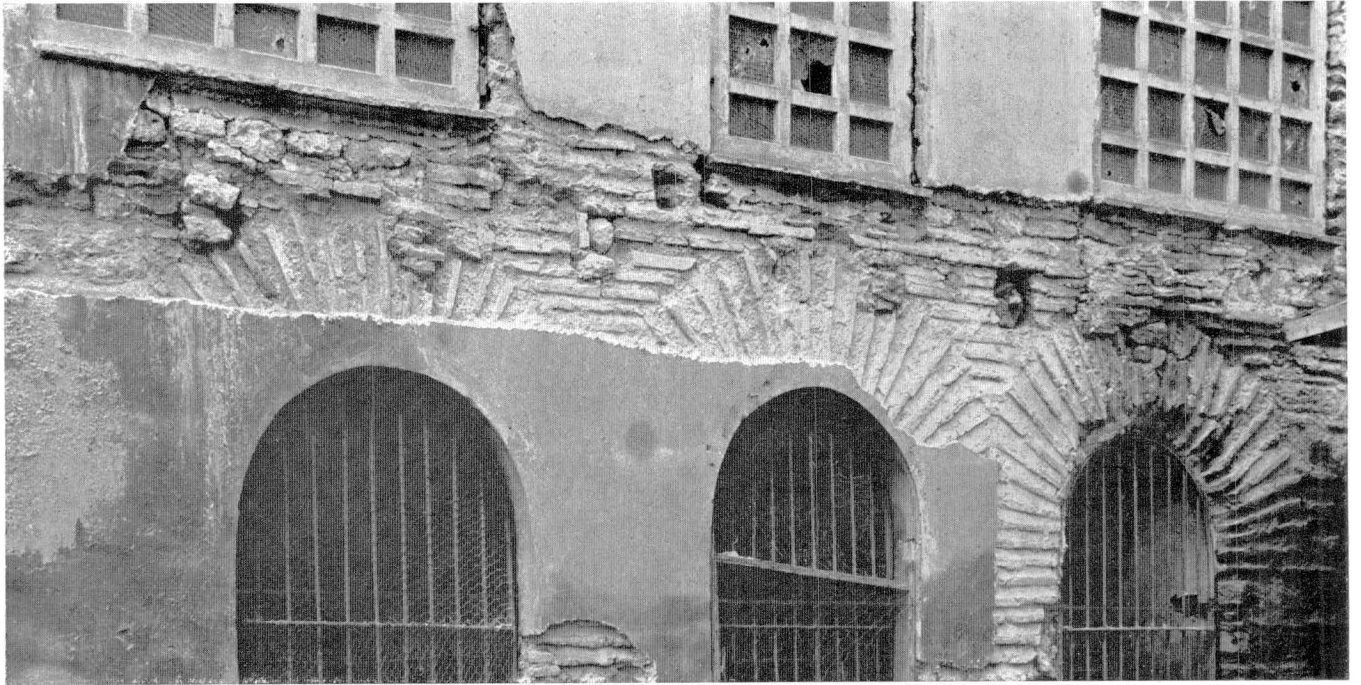
4. Exterior South Flank Wall of Naos

Numerous observations were made elsewhere on the superstructure of the interior, on the exterior, and on the roof; and they will be presented in subsequent reports as their significance becomes clear. One, however, is worth recording at this point, since it bears directly on an issue in which Kalenderhane has always figured: that of the five-aisled plan.⁹ Soundings on the exterior walls of the crossarms of the naos, above the triple arcades, revealed post holes that could only have been set in the course of the original construction of the naos (fig. 4). It is premature to speculate on what sort of structure these holes supported; but some type of structure flanked the naos to the north and south, and was accessible, as we have suggested above, through the arcades in the crossarms. The structure—perhaps a porticus—may have extended to the west to include the flanks of the esonarthex, since the esonarthex was originally opened by doors in its north and south walls, and the masonry to each side of these doors differs from that of the naos.

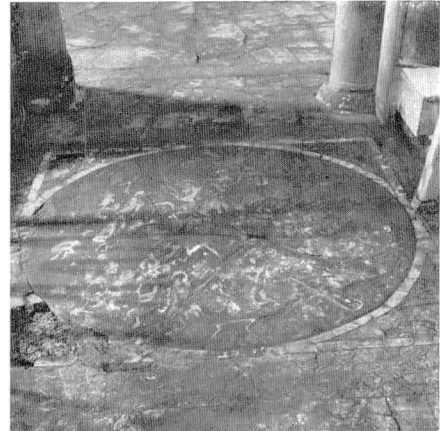
6. Porphyry Disc in Naos Floor, looking West

At the commencement of our work, the floor of the naos and bema was covered with a late wooden floor in poor repair. Its removal revealed an ornamental pavement in the central axis of the naos, of polychrome marble slabs disposed in a simple rectilinear pattern consonant with the decor of the wall revetment. A porphyry disc 2.65 m. in diameter is set into the paving on the central axis directly in front of the main entrance to the naos (fig. 6), and a smaller granite disc, 1.30 m. in diameter, is set into the east end of the bema floor on the same axis, now partially overlaid by the Turkish mihrab (fig. 7). Directly to the west of the disc a reused marble inlay frieze, with inhabited palmette motifs, is set into the bema floor, originally spanning its width. Its southern part is likewise covered by the mihrab (fig. 7).

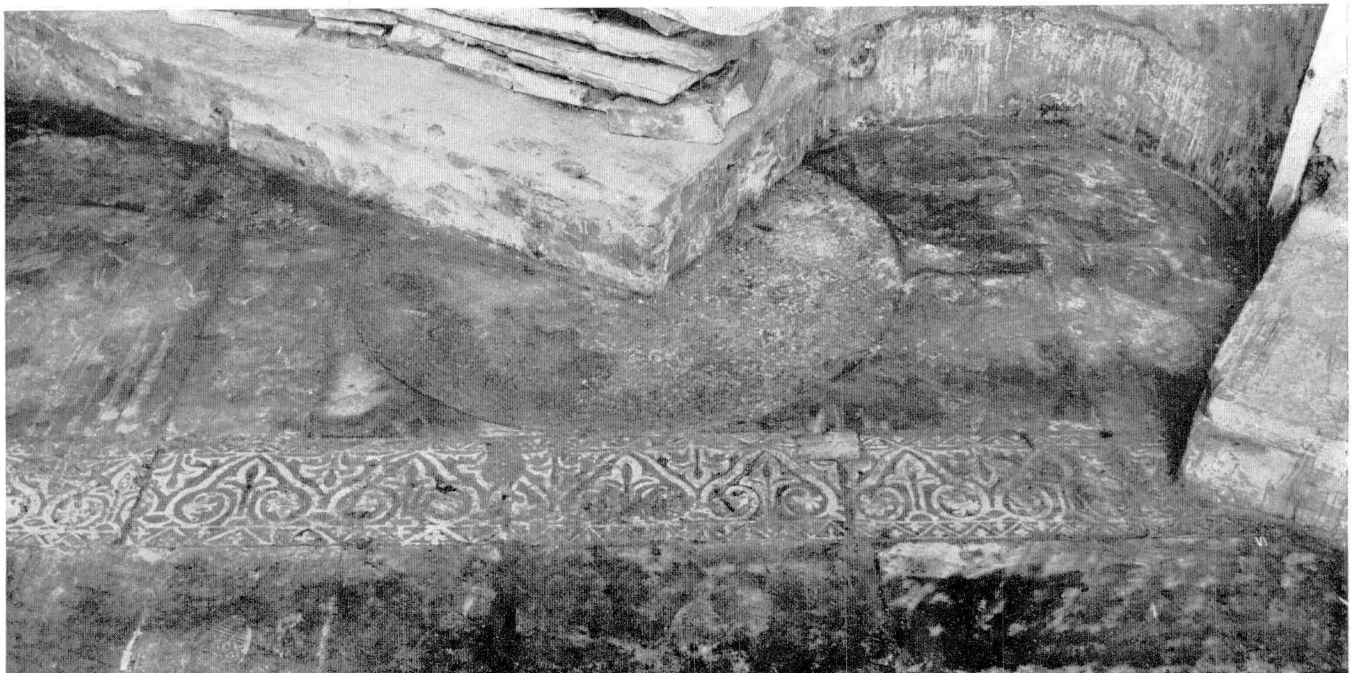
7. Disc and Frieze in Bema Floor, looking East
